GEOLOGIC AND GEOTECHNICAL INVESTIGATION

1925 EL CAMINO DE LA LUZ
SANTA BARBARA, CALIFORNIA

OCTOBER 2012

SUBJECT: **Geologic and Geotechnical Investigation**
RE: 1925 El Camino De La Luz
 (Proposed Single-Family Residence - APN 045-100-024)
 Santa Barbara, California

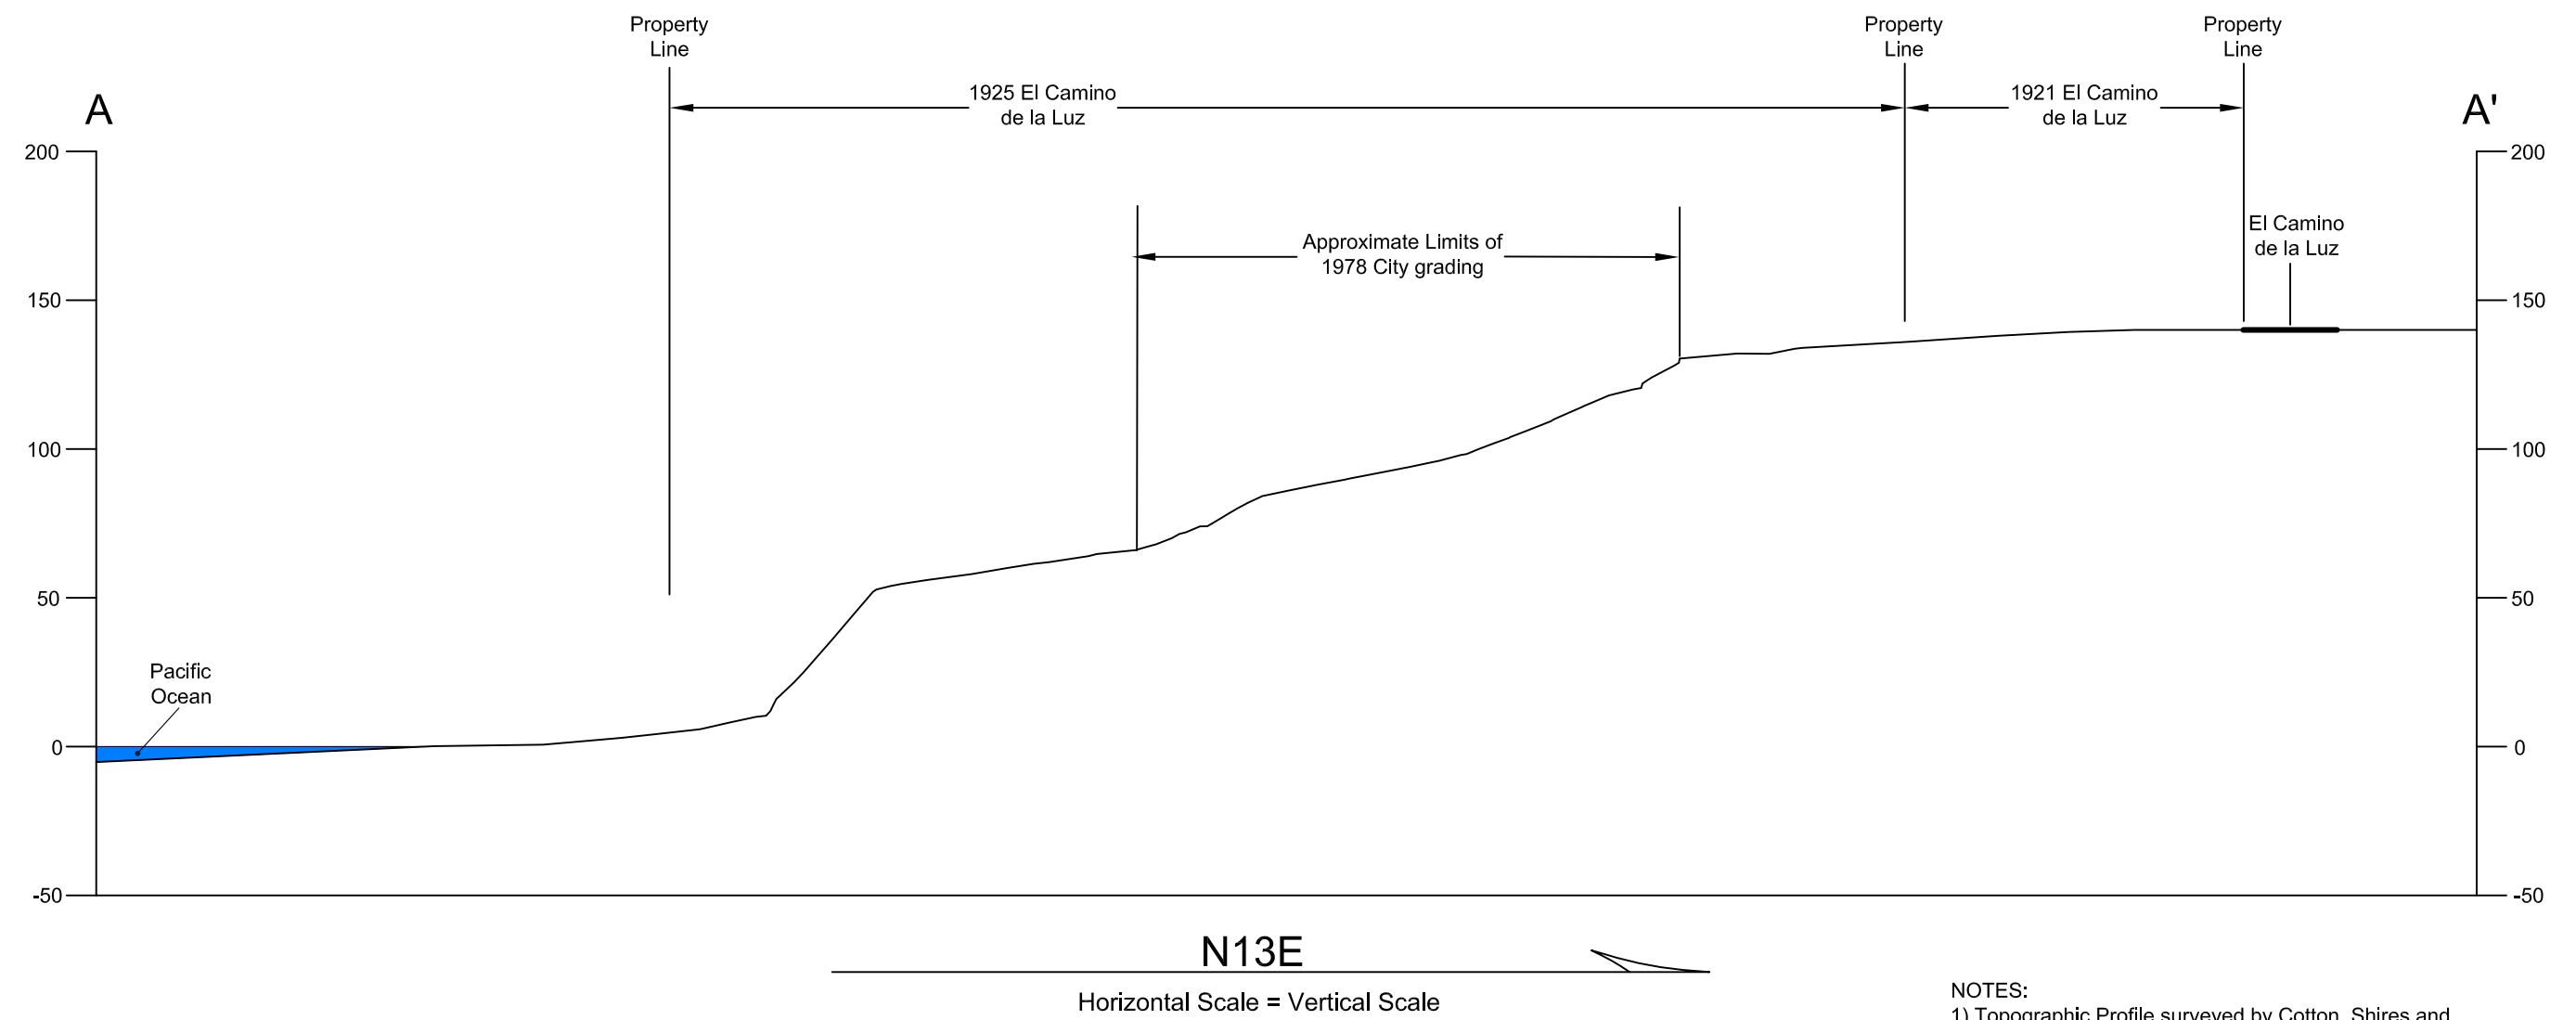
The parcel, as illustrated by the topographic profile of Figure 2, clearly has a well-defined top of coastal bluff approximately 288 feet south of the east-west property line with the adjacent 1927 El Camino De La Luz parcel. This top of coastal bluff (including the fact that it was lowered by grading in 1984) is consistent in its trend across the parcel and adjacent parcels, and has been in this approximate position and in this form dating
